## Dublin City Council

Parnell Road, Grand Canal, Dublin

Reinstatement of Failed Manhole

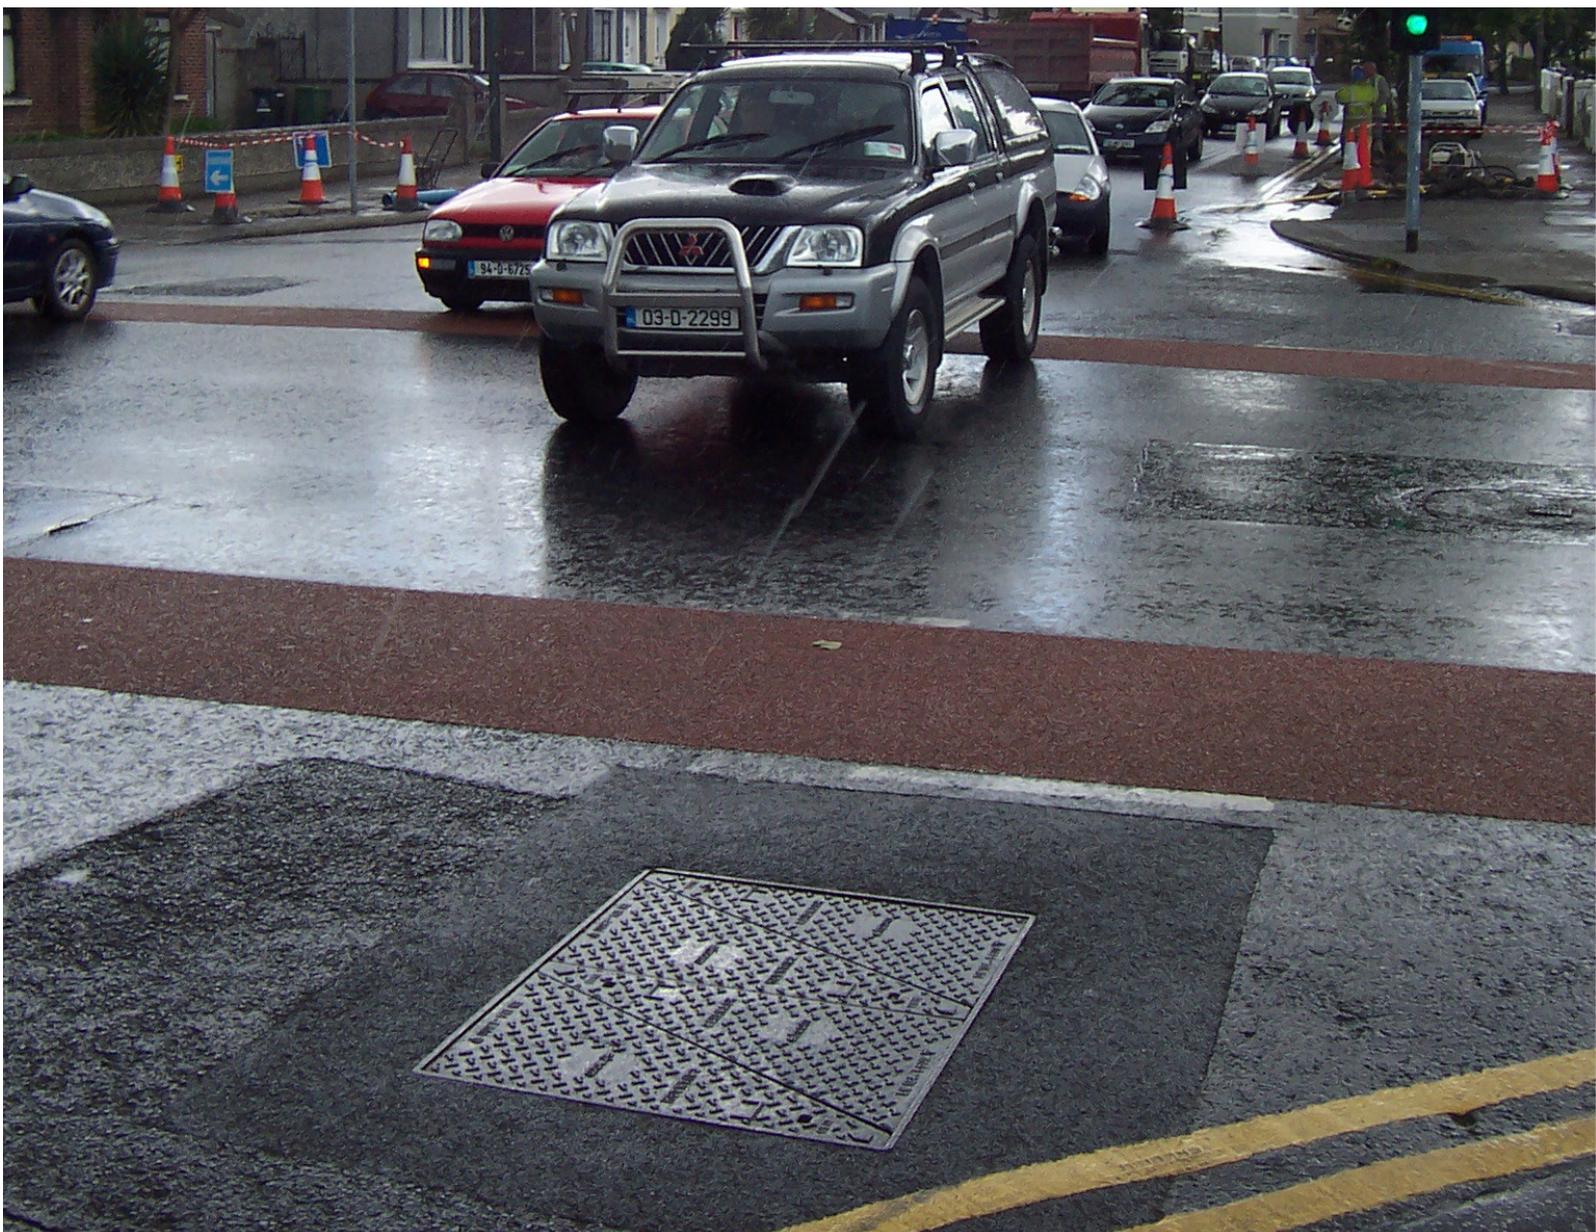
The city of Dublin, Ireland's largest city and its capital is the home to over one million people. The city attracts thousands of people each year and is well known for its lively and friendly culture. With the population and number of tourists growing year on year, consideration needs to be given to the effect that this is having on their roads. More vehicles, usually equals more road maintenance activity which often results to an increase in unhappy commuters. Due to an increase in traffic volume and the use of sub-standard materials, Dublin City Council had noticed a number of failed manholes that needed to be repaired. The manholes were associated with Eirecom Telecommunication, therefore they approached Emtex Ltd, Irelands Highways specialist supplier, who recommended Instarmac's recently BBA/HAPAS approved Ironwork Reinstatement System.

The failed manhole, located at a busy crossroads on Parnell Road, which is a major road in Dublin, was excavated ensuring that all loose debris was removed. M60, a rapid set bedding mortar was chosen to bed a layer of block work in the chamber. PY4, a polyester resin mortar was then chosen to bed the ironwork as it complies with the required tensile and compressive strengths as stipulated in the Highway Agency Design Manual for Roads and Bridges HA104/02. QC10, was chosen to backfill the reinstatement, as the rapid strength concrete provides the ideal base for the final surfacing macadam. The next step to this system was to seal the vertical edges of the ironwork reinstatement to instantly prevent the ingress of water, using SCJ, bitumen cold joint sealer. The final stage of the reinstatement involved the use of Instant Road Repair (IRR). The BBA/HAPAS approved cold lay macadam is designed for first time permanent repairs to type 2/3/4 roads.

The ironwork reinstatement was completed in a very short space of time is expected, resulting in very little disturbance to passing traffic. The system has an anticipated service life of 5 years, which will mean long-term cost & time savings for the local authority. Representatives from the Instarmac Group plc, when revisiting the reinstated manhole 3 years on, reported that the manhole was still going strong showing no signs of failure as expected!
